**EXISTING CONDITIONS STUDY
SANDS RING HOMESTEAD
180 MAIN STREET
CORNWALL NEW YORK**

July 2015

PRESERVATION ARCHITECTURE
Marilyn E. Kaplan, Architect and Principal
43 Marion Avenue
Albany, New York 12203
518-459-6460
518-459-6463
preservationarchitecture@verizon.net

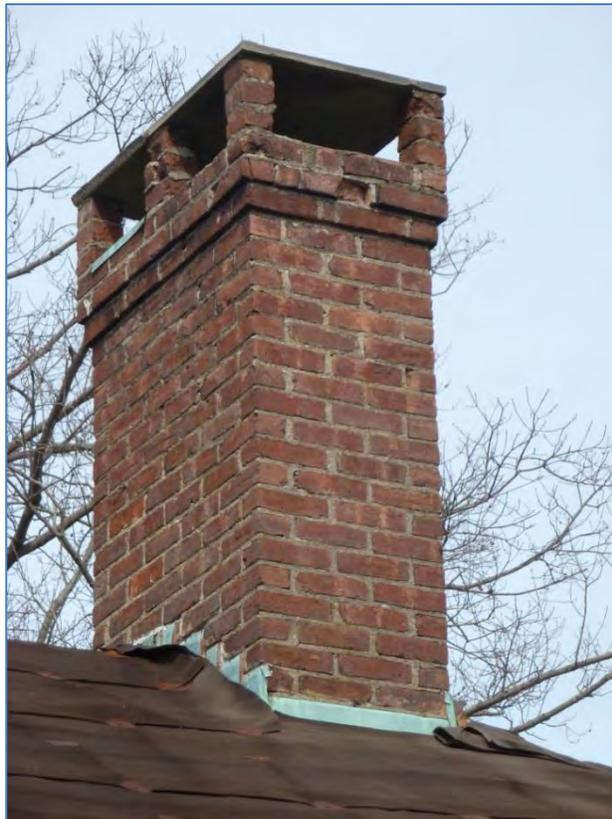
The 3 brick chimneys were constructed at different periods, and may have been last repaired in 1956. The extent of restoration of the chimneys in 1956 or subsequent to that date is unknown. To be confirmed is which chimney is used to vent the furnace currently located in Room 209. The masonry details of chimneys vary slightly, although all have stone caps and copper flashing and counter flashing. Only one chimney retains the corbeling detail shown in the 1956 drawings.

- Chimney 1, Room 204 (ceiling plaster; may be associated with roofing failure)
- Chimney 2, Room 202 (ceiling plaster)
- Chimney 3, Room 100 (ceiling plaster)

Photo 11. Chimney 2, from East.

Restore/rebuild all chimneys. Include repair/replacement of flashing and deteriorated brick masonry. Further, close-up examination may determine the need to rebuild one or all chimneys from the roofline up. Chimney repairs should be coordinated with long term plans for building heating in order to ensure the adequacy of the existing flue(s) for future intended purposes.

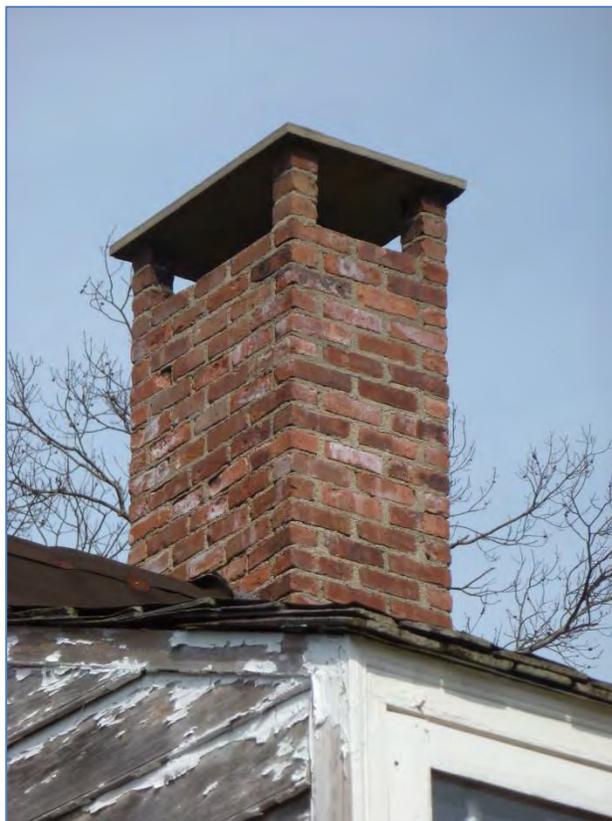
Photo 12. Chimney 1, from East.

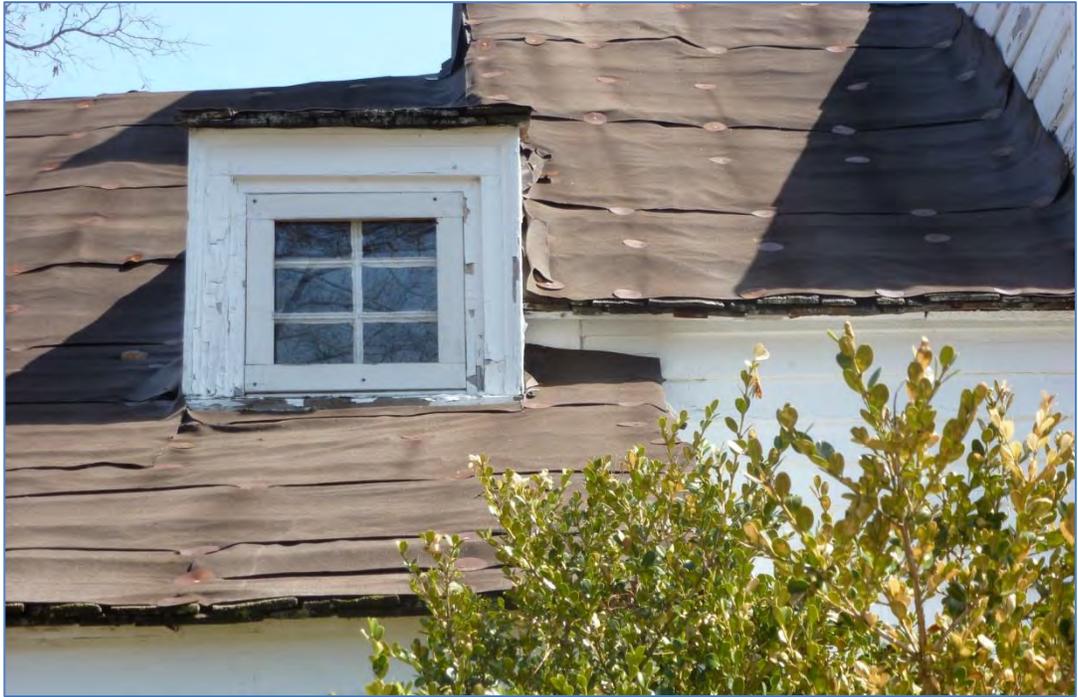
The existing 7 wood dormers were constructed at different times: at a minimum, Dormers 6 and 7 are understood to have been repaired and rebuilt in 1956. Some of the current damage at interior wall and ceiling surfaces at first and second floors is associated with failure of dormer roofs, flashing, and/or windows. Damage includes paint and plaster failure and indications of wood deterioration. Further investigations will confirm extent of wood clapboard and structure requiring repair.

Photo 13. Dormer 5, Window WW-9, from West.

Restore all dormers completely. Work is likely to include stripping dormer roofs and siding; wood structure repair/reinforcement; new roofing, siding and trim; and window restoration. Work must be coordinated with the overall roof replacement project.

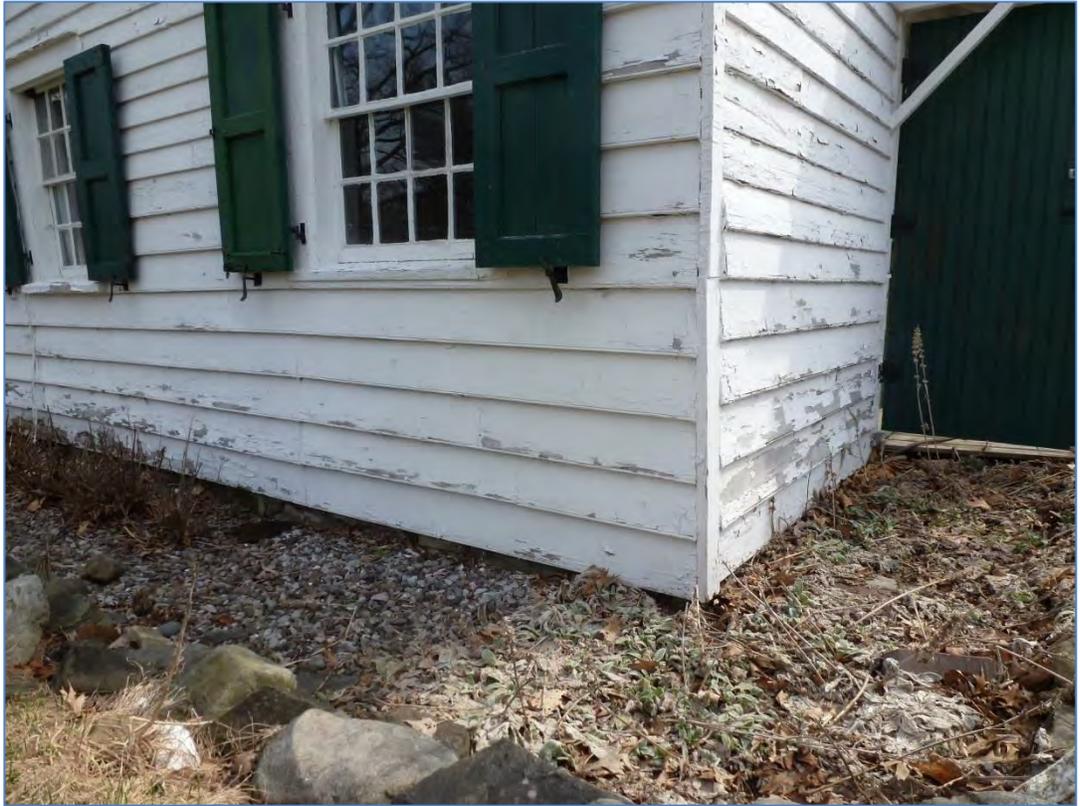
In most areas, wood appears to be in fair condition. Large areas of wood deterioration exist near grade (in particular at west elevation), and paint failure exists at all elevations. Most siding deterioration has occurred where wood is closest to grade. (At SE and SW corners wood is within 3" of grade, compared with NE corner where the height between grade and siding is as great as 14".)

Photo 19. Exterior siding at grade, SW corner.

Replace damaged wood siding and trim to match adjacent materials. Scrape and prepare sound and salvageable wood for recoating. Coordinate upper level repairs with roofing project, and lower level repairs with foundation repairs.

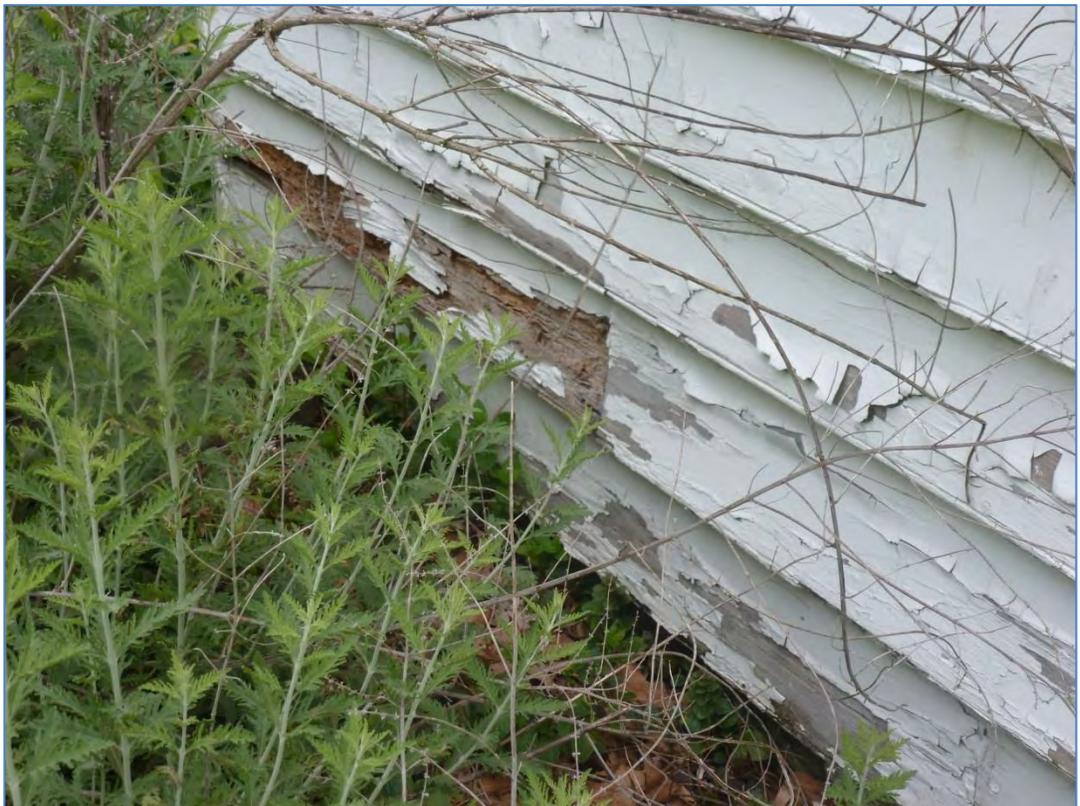
Photo 20. Wood siding deterioration, West elevation, outside of Room 103.

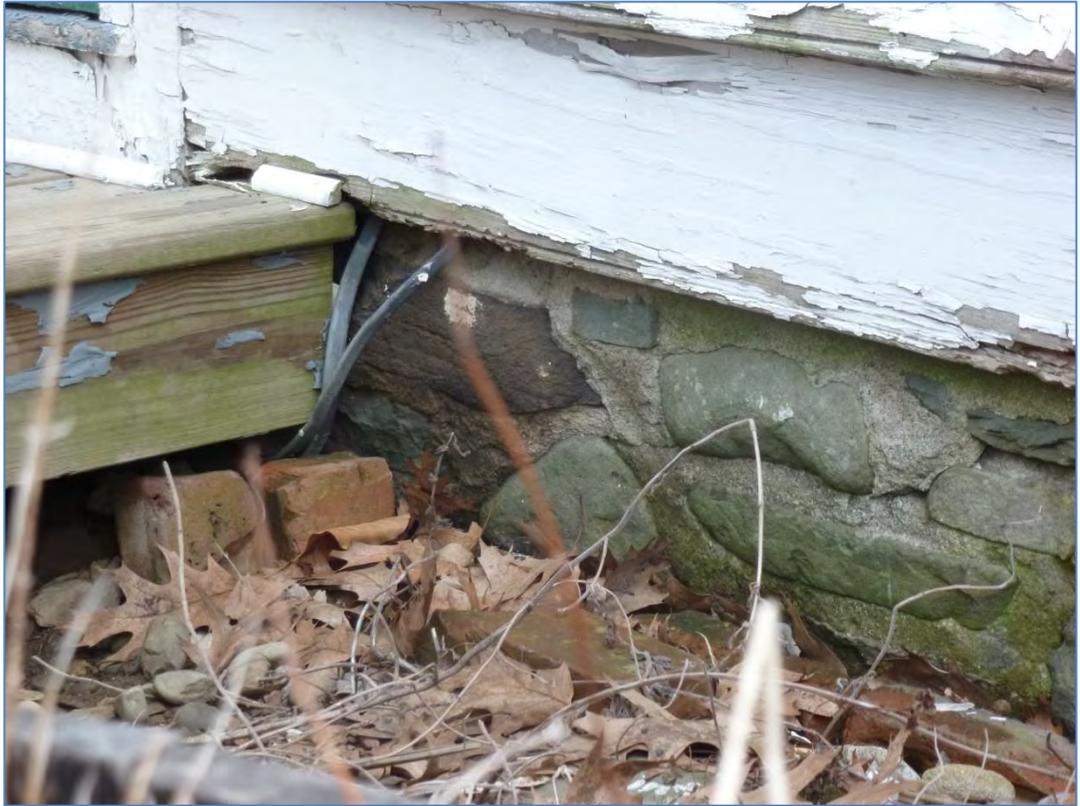
Photo 21. Water table deterioration.

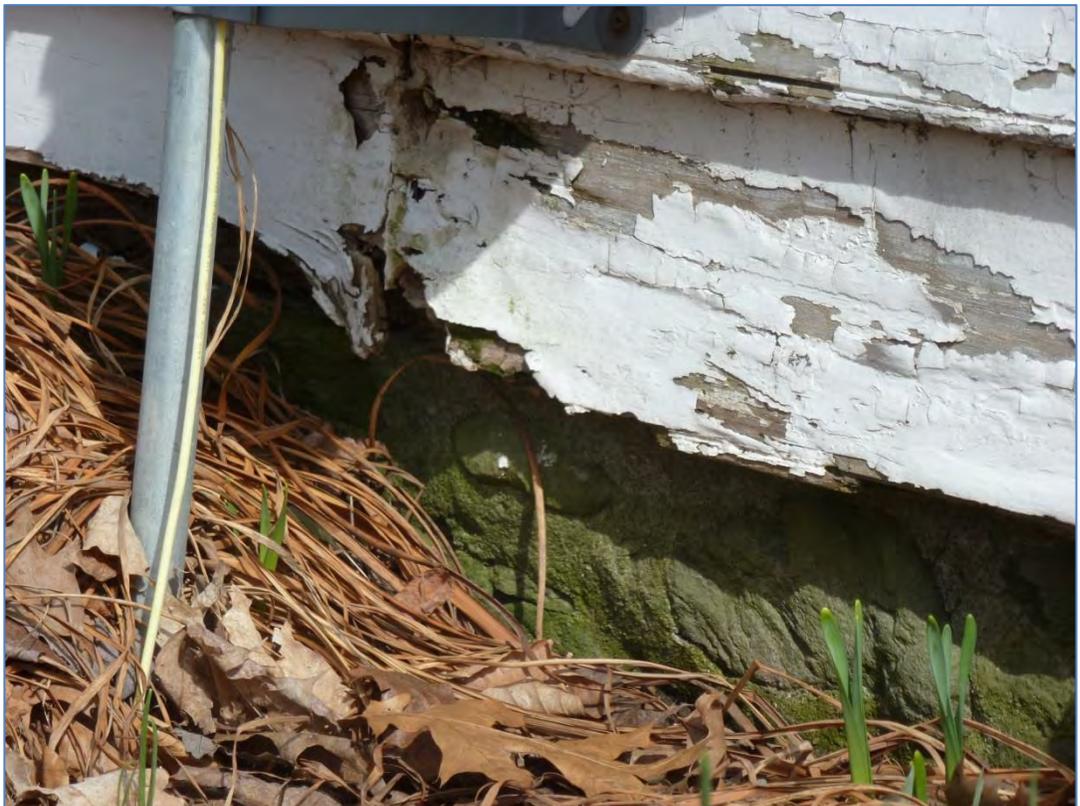
Photo 22. Water table deterioration, typical.

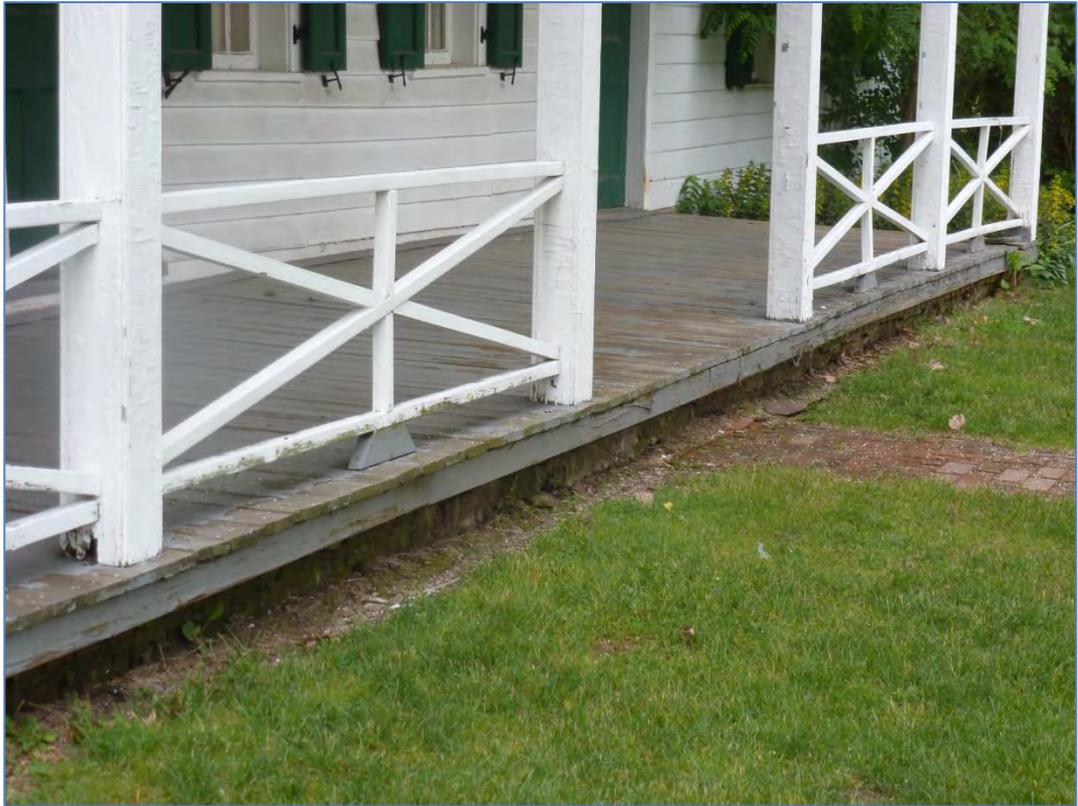
Both porches are in poor-fair condition. Decking, which appears to be or relatively recent vintage, is sound but has failing paint and some deterioration. Many posts exhibit extensive deterioration.

Photo 23. East verandah, porch deck.

Restore verandas based on existing conditions and additional research, in particular associated with posts and railings at the east elevation.

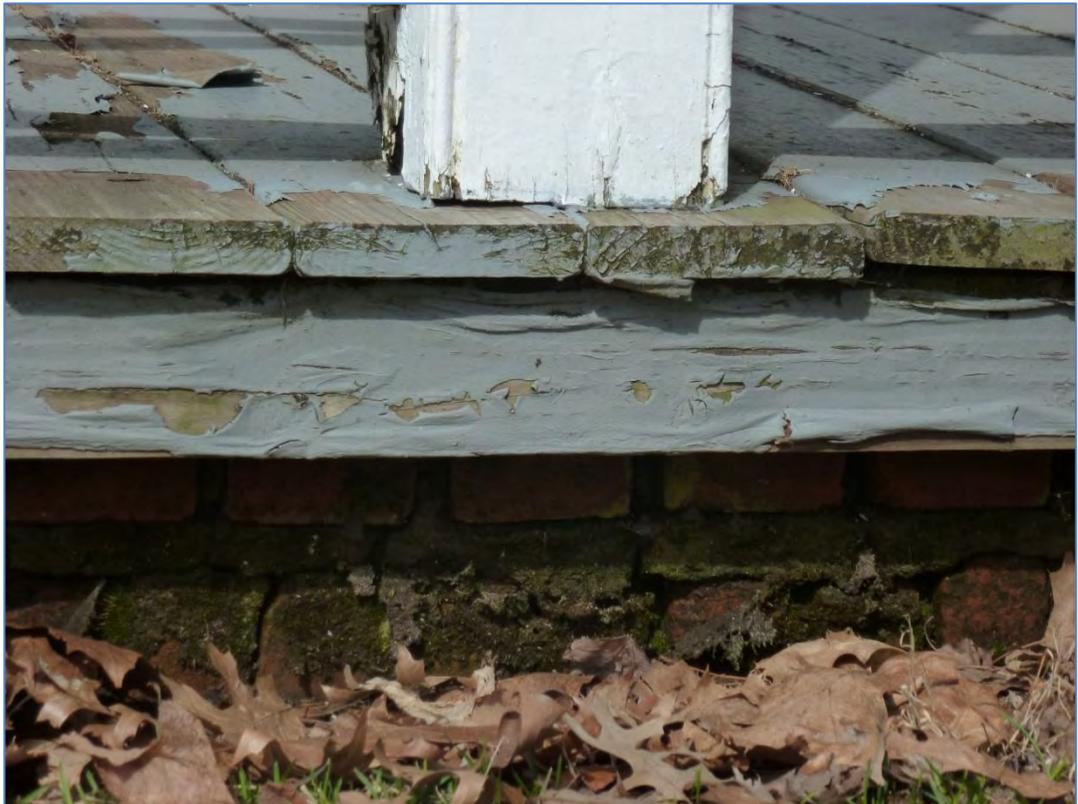
Photo 24. Porch column deterioration, West elevation.

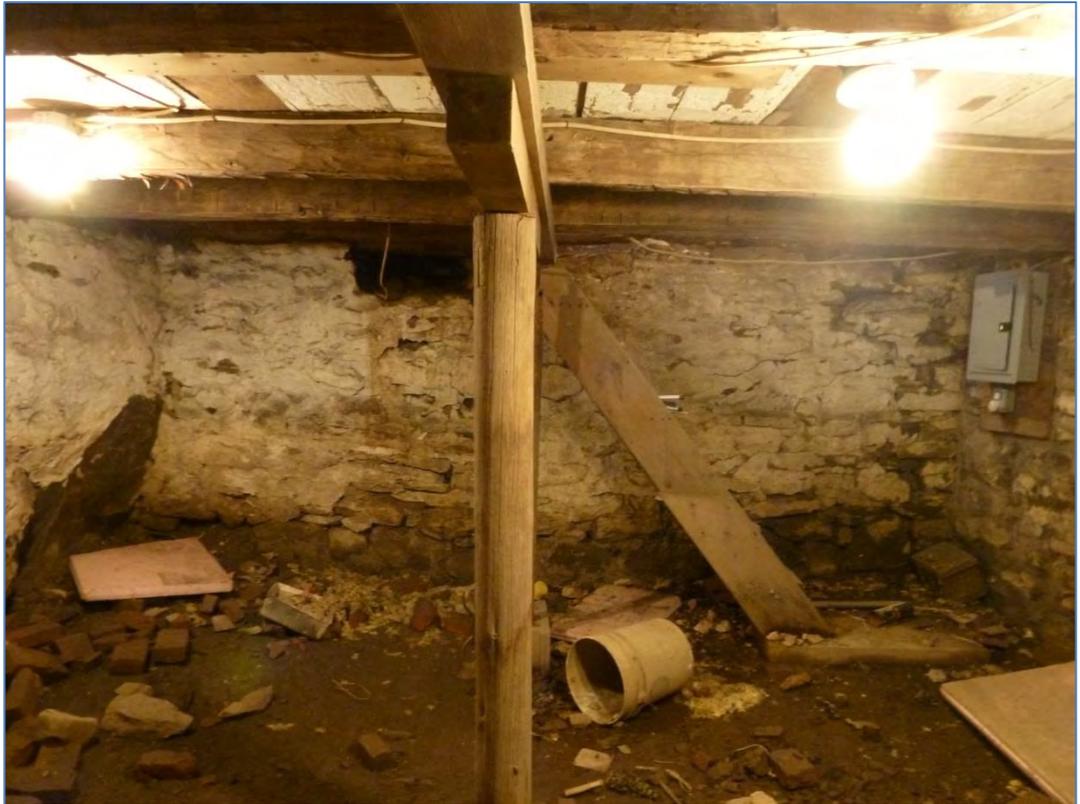
In Room 001, stone masonry walls, in particular at the NW and NE corners, are in particularly poor condition: stone displacement and some collapse have occurred. Openings at west and east walls, likely the location of an earlier basement entrance and exterior ventilation, respectively, have displaced stone and/or eroded mortar in joints. Additional masonry deterioration exists at other wall areas and at the fireplace.

Photo 25. Basement, Room 001, North wall.

Undertake masonry repairs in Room 001 immediately, with scope determined in consultation with structural engineer. It is most critical that NE and NW corners, and the areas of the fireplace supporting the hearth and fireplace above, be addressed. Basement level stone masonry repairs should be coordinated with any required wood floor joist and posts repair/replacement, and include proper footings.

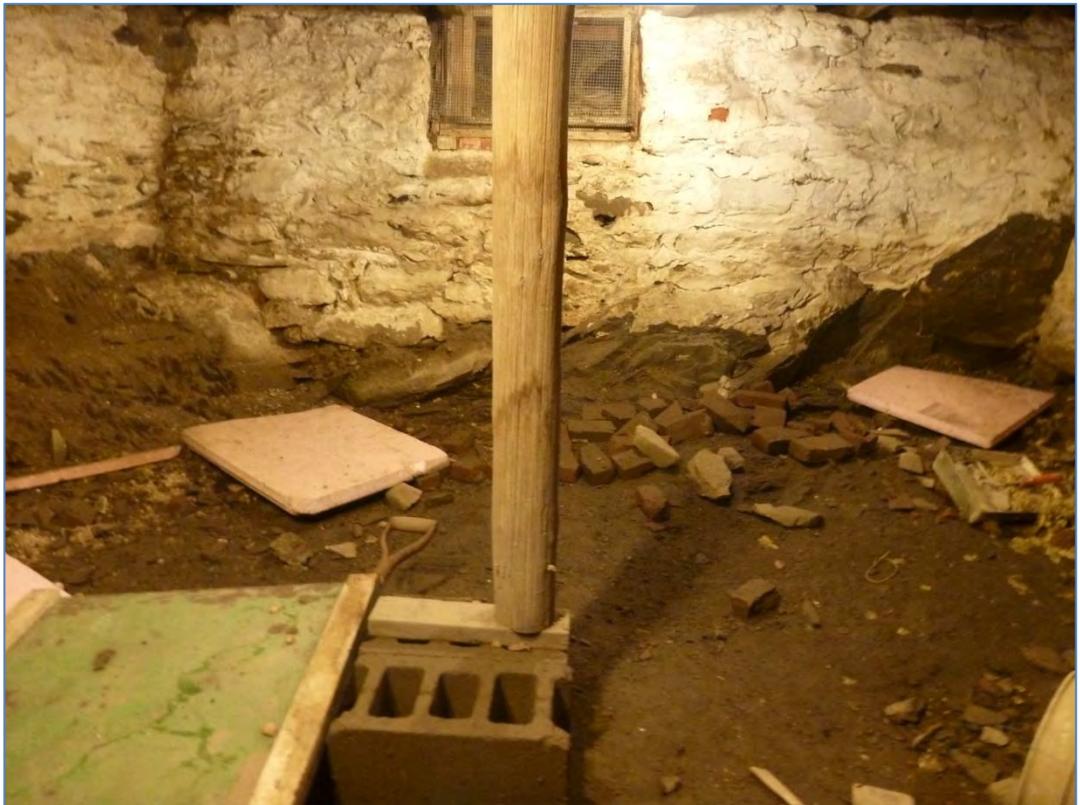
Photo 26. Basement, Room 001, East wall.

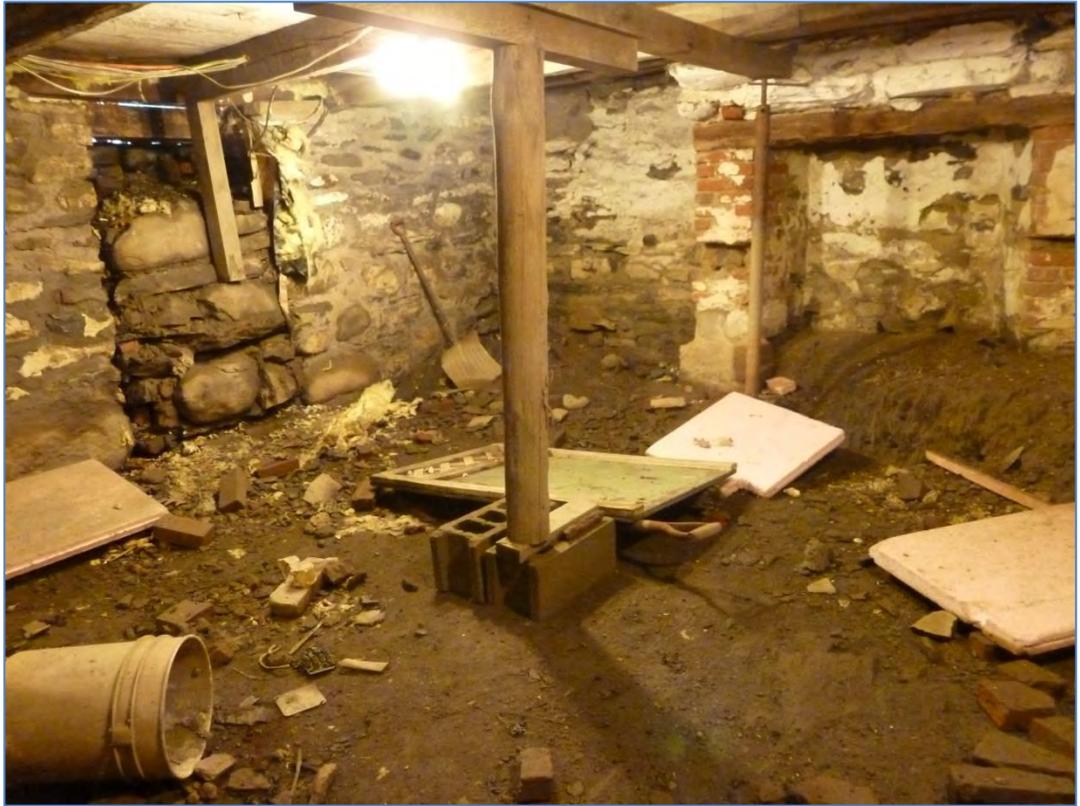
Photo 27. Basement, Room 001, looking NW.

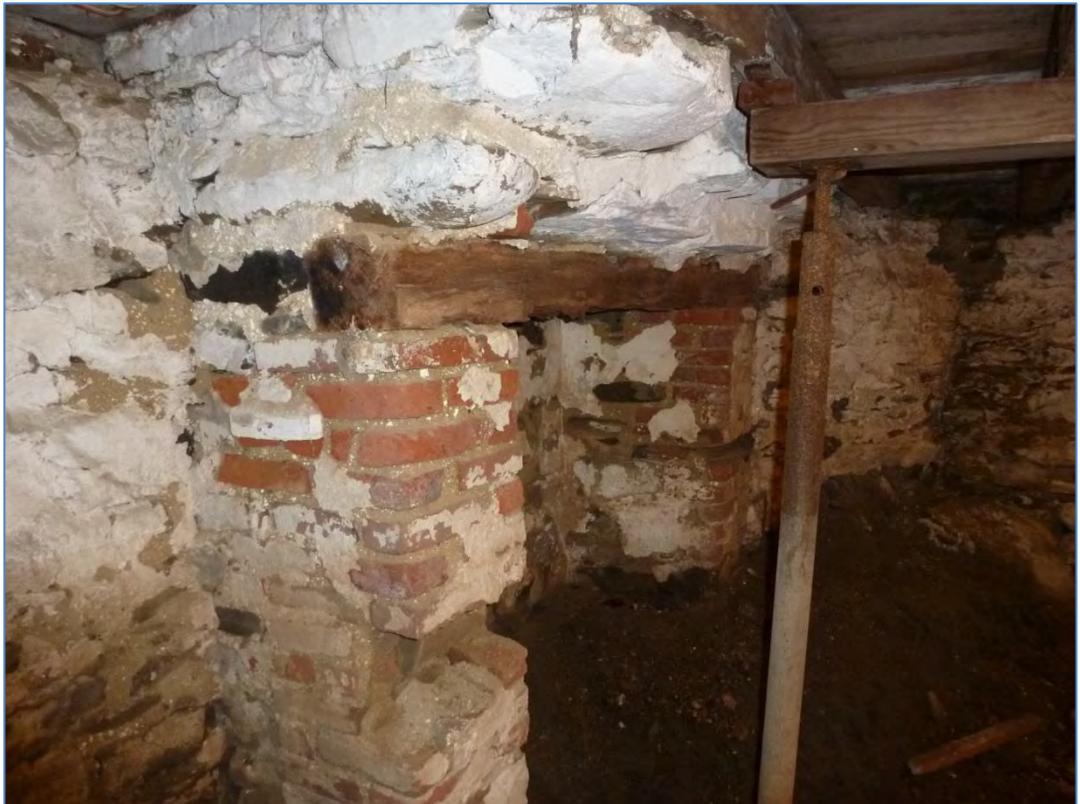
Fireplace	The original/early brick fireplace at the north elevation is in extremely poor condition. Stone and brick supports have collapsed, and support for hearth above is in extremely precarious condition.	Restore fireplace to stabilize: repair/replace wood framing members; repoint, rebuild as required including replacement of damaged brick.	9	\$25,000
Wood Joists	Much reinforcement of wood joists has occurred, although extensive damage and deterioration is visible. Worst conditions exist at bearing points on stone masonry walls.	Replace or reinforce 1 st floor joists and beams. Replace added columns/posts as required. Include measures for insect control.	10	\$30,000

Photo 30. Basement, North wall fireplace.

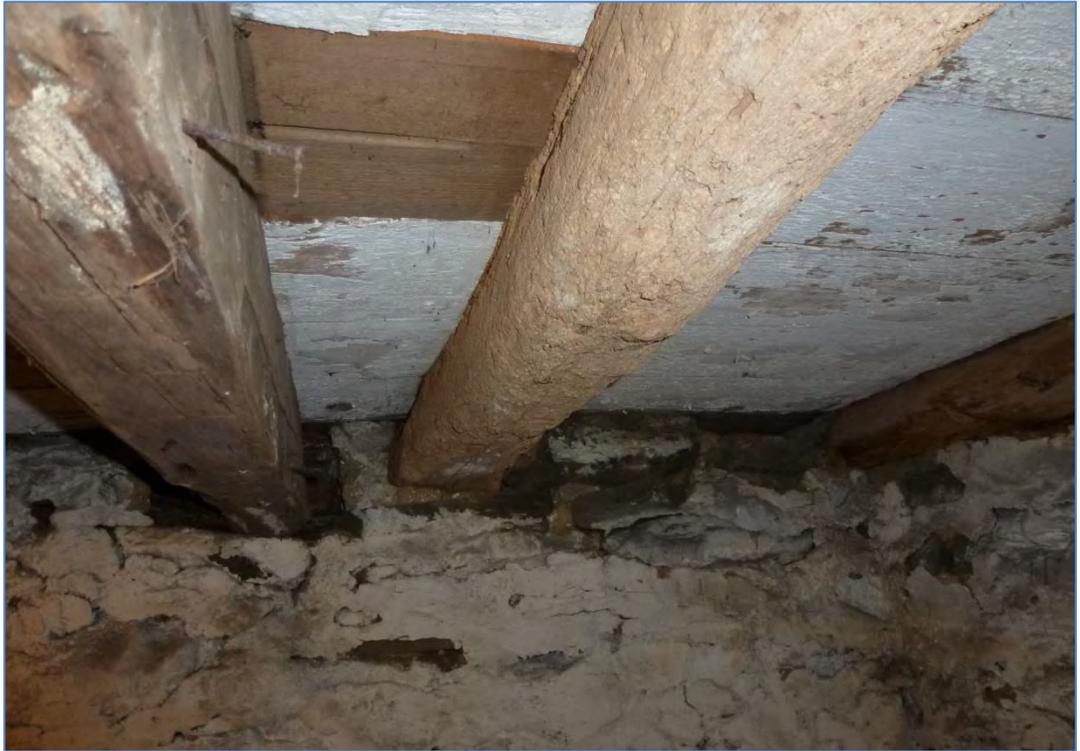
In Room 001, deterioration of first floor wood joists, including from insect infestation and wood deterioration at bearing ends of stone masonry walls, was observed. Further investigations will determine the condition and reinforcement needs of these members, and the extent of damage of wood sills above the foundation walls and supporting the wood joists. Engineering assessment relative to structural capacity should also be part of further investigations.

Photo 31. Basement, first floor framing, East wall.

Coordinate wood structure repairs in basement with masonry repairs in that area. Include repair or reinforcement of wood structure, and treatment to address future insect infestation, as required. If additional wood structure reinforcement is recommended by engineer, coordinate with other repairs noted herein.

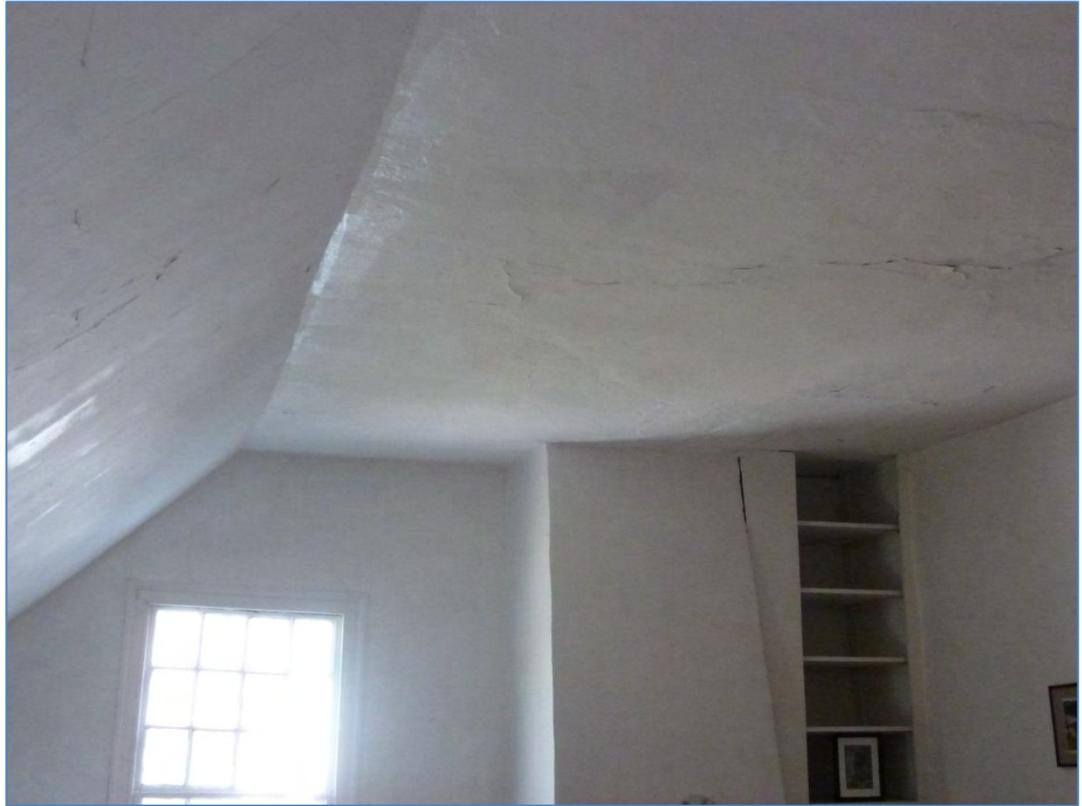
Photo 65. Second Floor, Room 204, North elevation, water damage at ceiling.

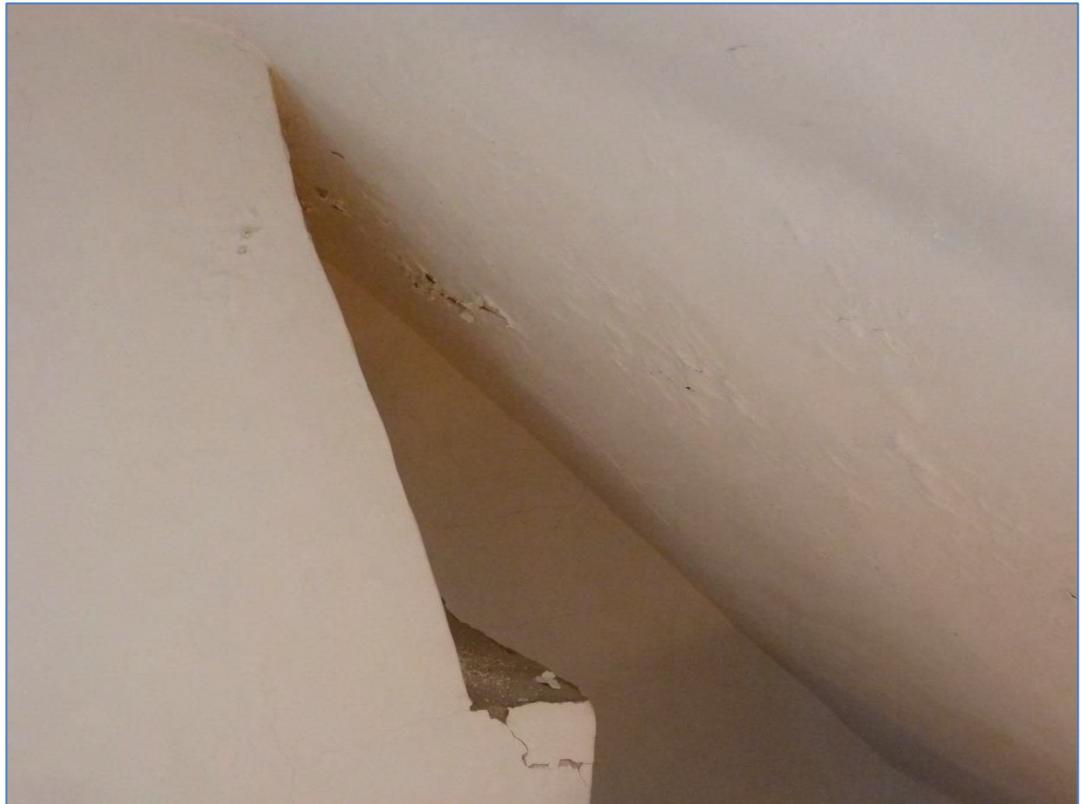
Photo 66. Second floor, Room 200, NE corner, ceiling damage.

7 INTERIOR				
Plaster Repair	Damage to interior walls and ceilings has occurred as a result of water entry at roofs, dormers, and window locations.	Undertake plaster repairs in rooms and areas where deterioration has occurred.	22,23,24,25	\$50,000
Electrical	Electrical equipment and wiring is dated and requires upgrade.	Based on findings of electrical survey, upgrade electrical systems throughout. Include new/upgrading lighting as required.		\$35,000
Fire Protection	Fire protection is inadequate.	Install new fire detection system throughout.		\$25,000
CONSTRUCTION TOTAL				\$827,000

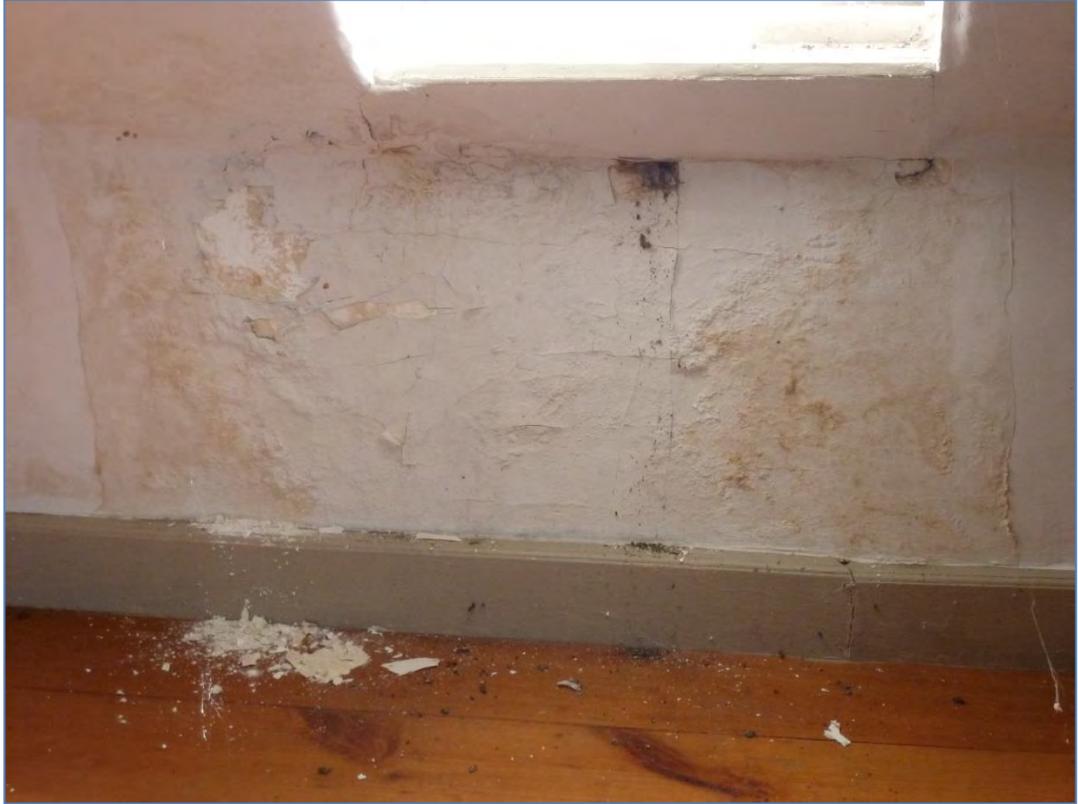
- Dormer 6/window WW8, Room 102 (ceiling)
- Dormer 6/window WW8, Room 202 (lower wall)
- Dormer 4/window EW11, Room 200 (lower wall, extreme deterioration)

Photo 67. Room 200, East wall, Window EW-11.
