**EXISTING CONDITIONS STUDY
SANDS RING HOMESTEAD
180 MAIN STREET
CORNWALL NEW YORK**

July 2015

PRESERVATION ARCHITECTURE
Marilyn E. Kaplan, Architect and Principal
43 Marion Avenue
Albany, New York 12203
518-459-6460
518-459-6463
preservationarchitecture@verizon.net

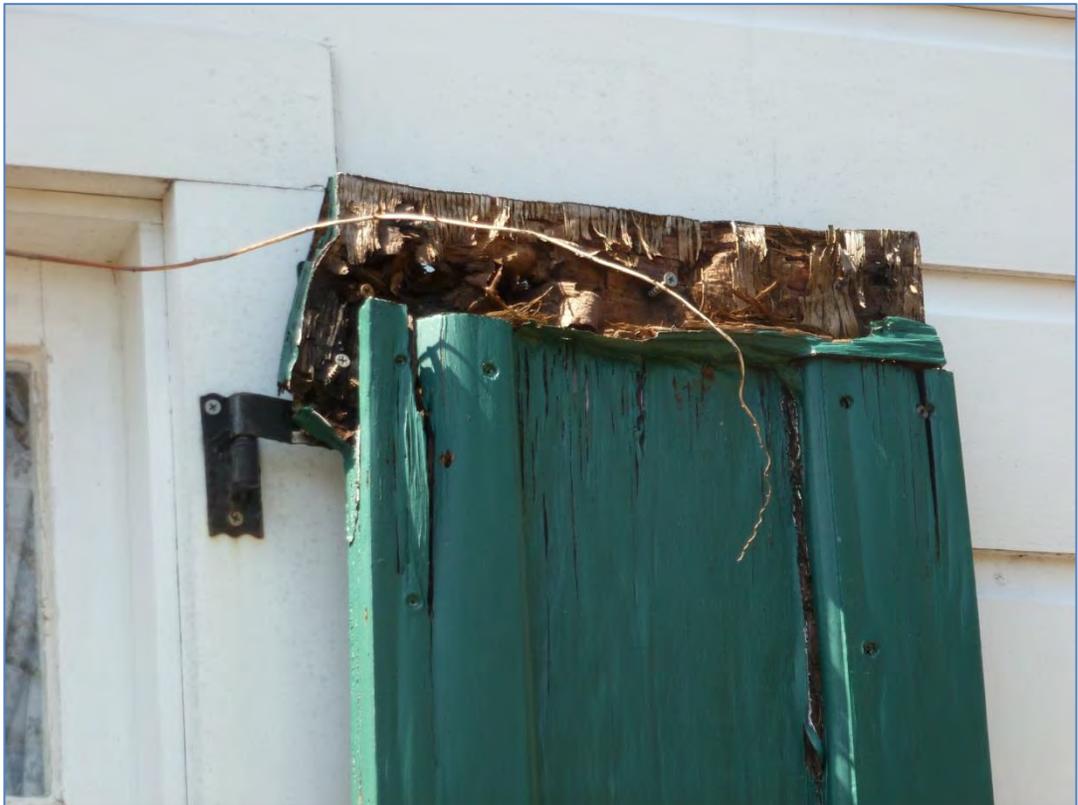
Photo 18. Shutter (later, plywood) at Windows EW-7, East elevation.

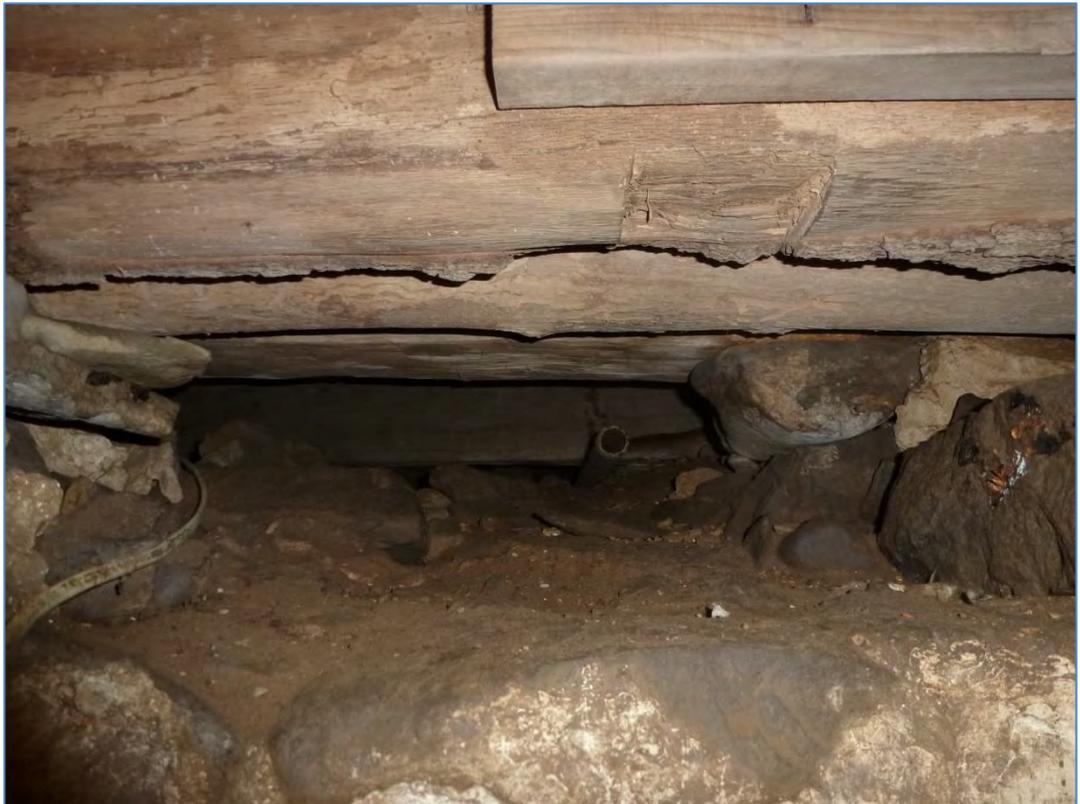
Photo 28. Basement, Room 001, looking North to crawlspace below Room 103.

In Room 001, stone masonry walls, in particular at the NW and NE corners, are in particularly poor condition: stone displacement and some collapse have occurred. Openings at west and east walls, likely the location of an earlier basement entrance and exterior ventilation, respectively, have displaced stone and/or eroded mortar in joints. Additional masonry deterioration exists at other wall areas and at the fireplace.

Undertake masonry repairs in Room 001 immediately, with scope determined in consultation with structural engineer. It is most critical that NE and NW corners, and the areas of the fireplace supporting the hearth and fireplace above, be addressed. Basement level stone masonry repairs should be coordinated with any required wood floor joist and posts repair/replacement, and include proper footings.

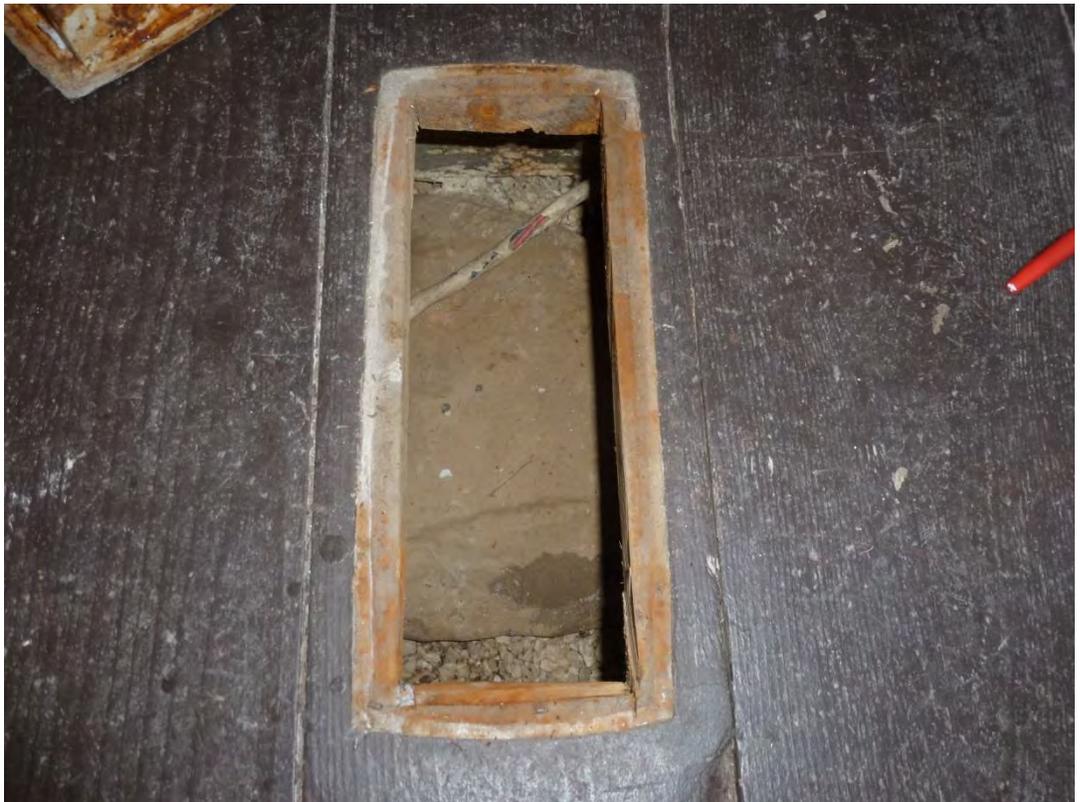
Photo 32. First Floor, Room 107, crawlspace below.

First floor wood joists in the crawlspaces were not accessible for inspection, but some deterioration is anticipated where joists are in contact with dirt below and/or at where joists bear on stone walls. At areas of lower walls requiring siding replacement, wood sills and wood joists ends may be able to be inspected as part of this work. Repair or reinforcement of wood structure may include lower sections of wood studs or posts, as noted in section A above.
